## **US 26/Parks Rd.-Porterville Rd.**

# US 26 at Parks Road/Porterville Road

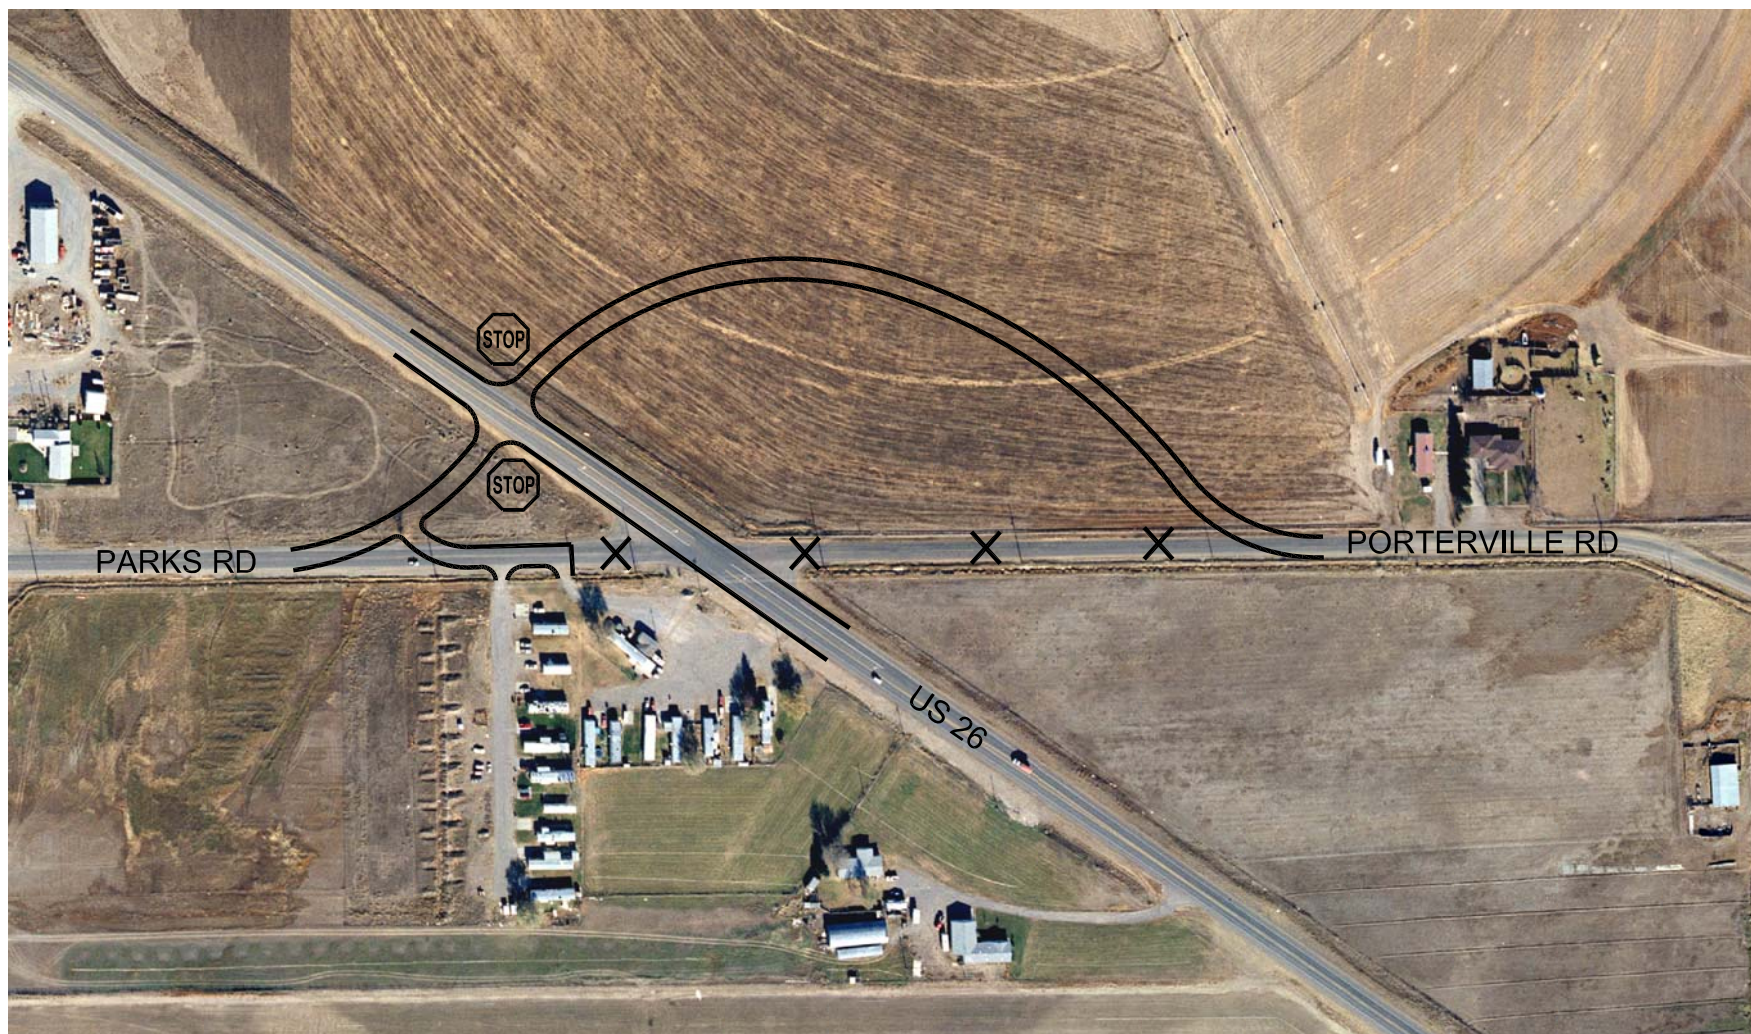
1. Close existing US 26/Parks Rd. – Porterville Rd. intersection (future improvement).
2. Realign Parks Rd. – Porterville Rd. at 90-degree angle with US 26 to the northwest of existing intersection (future improvement).
3. Widen median to allow two-stage crossing of US 26 at realigned Parks Rd. – Porterville Rd. intersection (future improvement).

**Figure 1**  
**Realignment of US 26/Parks**  
**Road-Porterville Road Intersection**

1. Two-stage crossing will provide adequate level of service because drivers will not be required to cross both directions of traffic along US 26 at same time.
2. Skewed angle of existing intersection would make turning maneuvers more difficult than if intersection was realigned at 90-degree angle with US 26.
3. Offset “T” intersections would result in more property impacts than realignment of existing intersection.

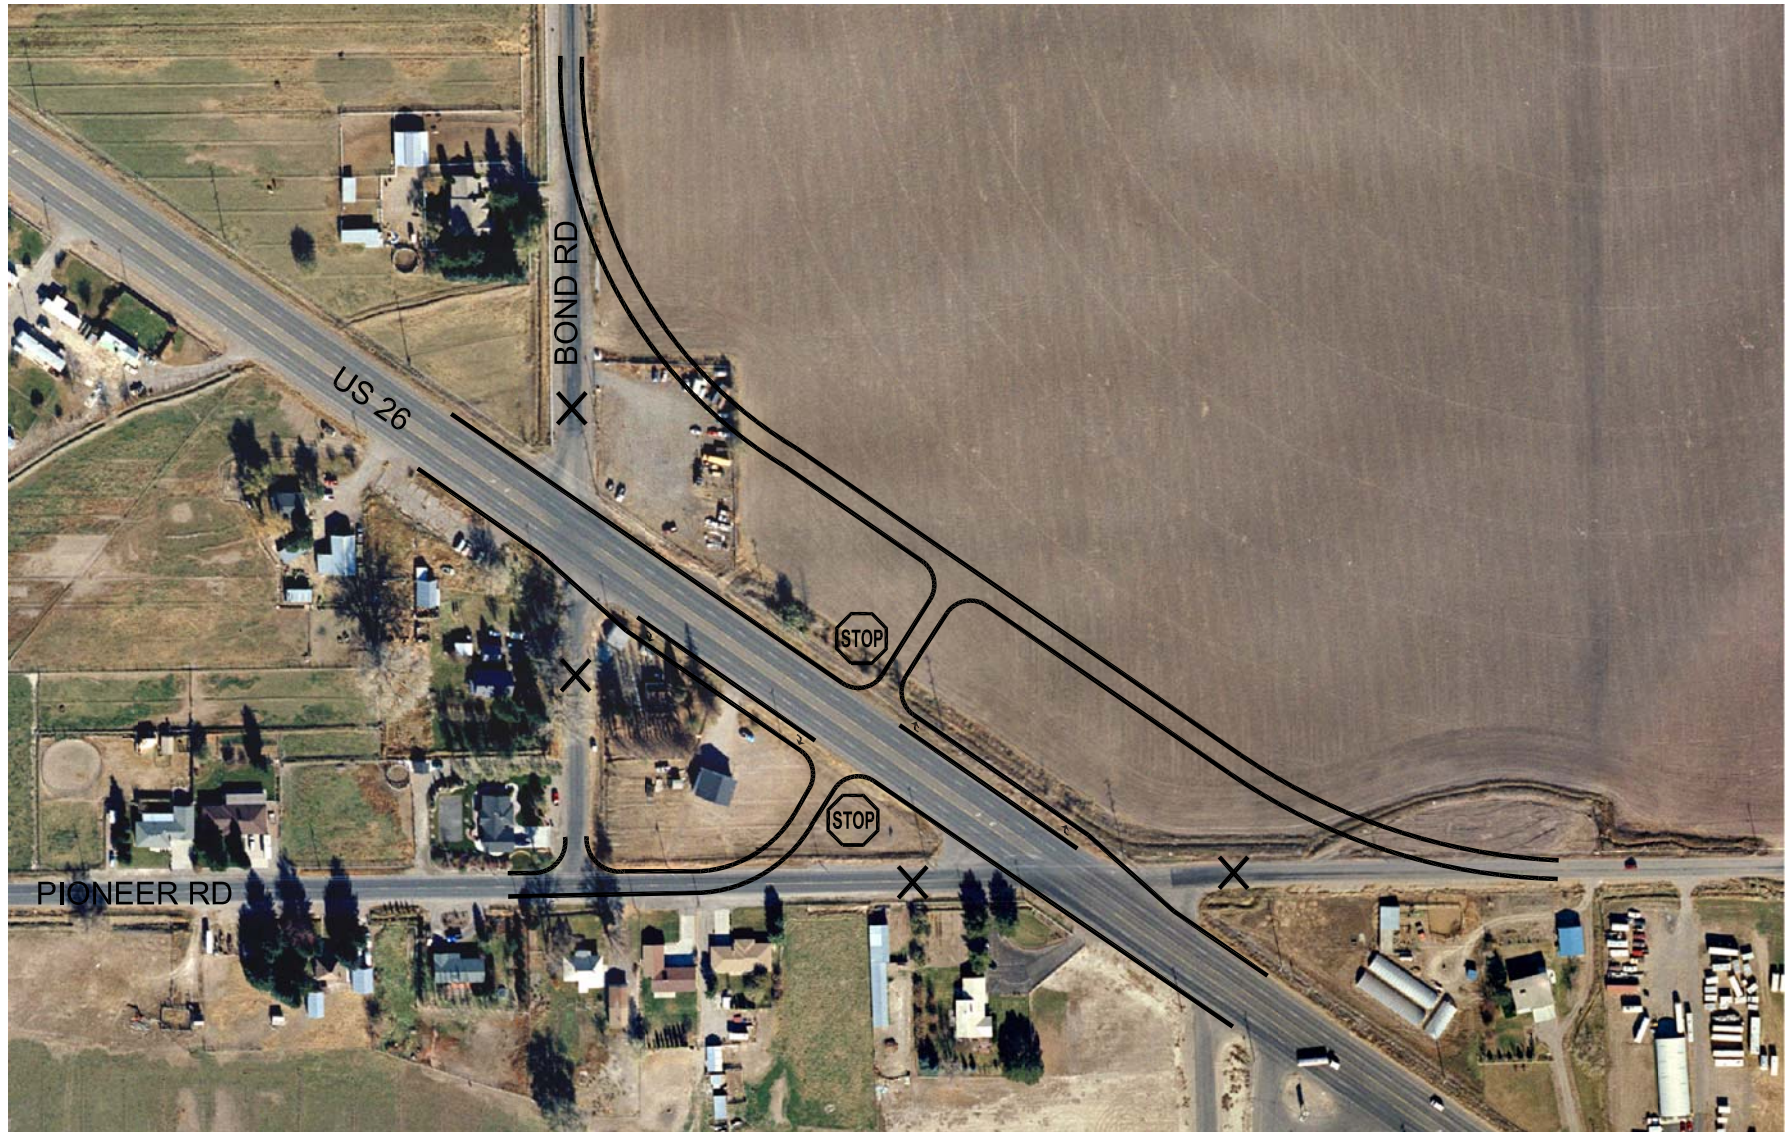
# ***US 26 at Pioneer Road/Bond Road***

1. Construct eastbound and westbound right-turn lanes on US 26 at Bond Rd.
2. Restripe centerlines on Bond Rd.
3. Construct westbound right-turn lane on US 26 at Pioneer Rd.
4. Install and adequately maintain pavement markings and delineation on Pioneer Rd., including at a minimum:
  - Centerline
  - Edgeline
  - Double width (24") stop bar
  - "STOP" pavement marking in advance of intersection
5. Install oversize stop sign on eastbound approach of Pioneer Rd.
6. Create new combined intersection between Bond Rd. and Pioneer Rd. with widened median to allow two-stage crossing of US 26 from Bond Rd./Pioneer Rd., with eastbound and westbound right-turn lanes on US 26 (future improvement).

**Figure 2**  
**Combined US 26/Bond**  
**Road-Pioneer Road Intersection**

1. Adequate pavement markings and delineation on Pioneer Rd. are necessary, basic improvements that should be installed and monitored for effectiveness prior to considering other improvements.
2. Speed hump and rumble strip on eastbound approach of Pioneer Rd. would not adequately address problem of drivers ignoring stop sign and may create additional problems.
3. Combined Bond Rd./Pioneer Rd. intersection would provide adequate future level of service and would eliminate skewed alignment at both existing intersections.

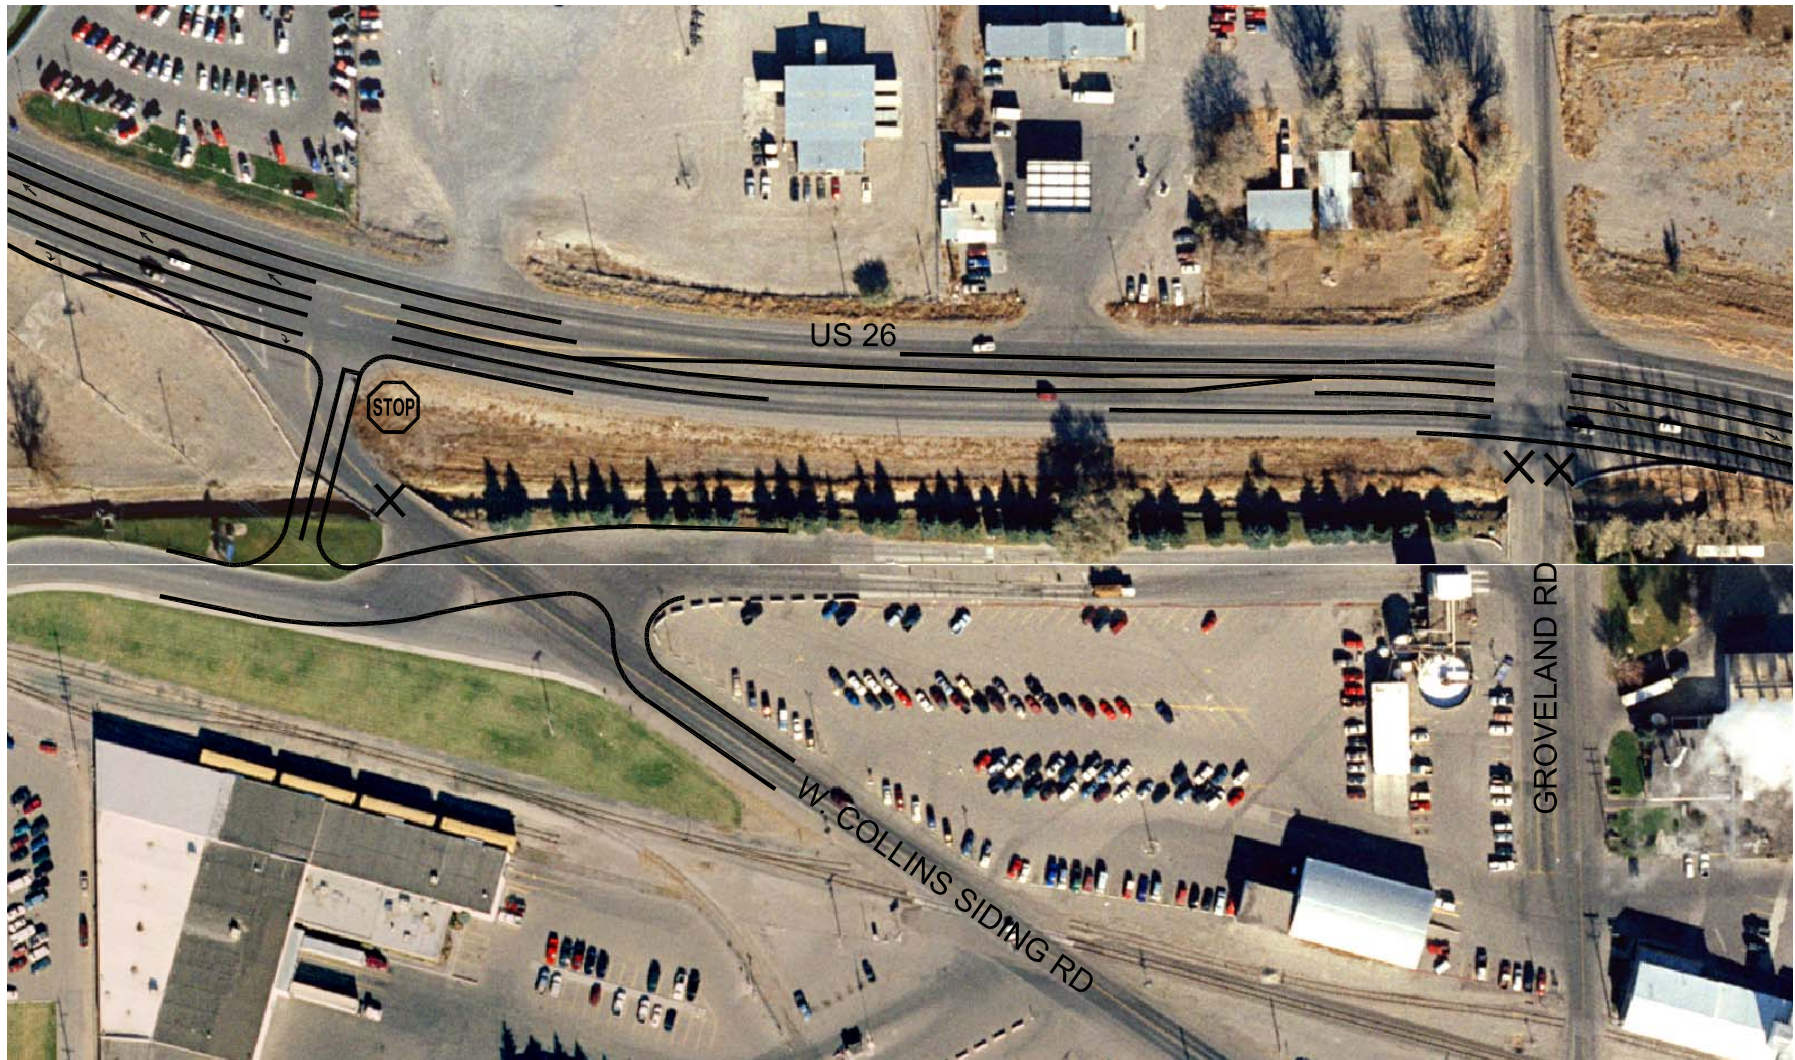
# ***US 26 at Groveland Road/W. Collins Siding Road***

1. Close south leg (Groveland Rd.) of US 26/Groveland Rd. intersection.
2. Convert existing westbound left-turn lane at US26/Groveland Rd. to acceleration lane for southbound left-turns.
3. Provide advance warning along US 26 about steam problem using Road Weather Information System.
4. Realign south leg (W. Collins Siding Rd.) of US 26/W. Collins Siding Rd. intersection.
5. Construct eastbound right-turn lane on US 26 at West Collins Siding Rd.
6. Install westbound acceleration lane in median area at US 26/W. Collins Siding Rd. (future improvement).

**Figure 3**  
***Realignment of US 26/West Collins***  
***Siding Road Intersection***

1. Closure of south leg of Groveland Rd. would address multiple deficiencies at US 26/Groveland Rd. intersection:
  - Eastbound right-turn lane on US 26 would not be needed.
  - Sight distance from northbound approach of Groveland Rd. would not be an issue.
  - Level of service would improve to adequate level (LOS "B").
  - Would allow conversion of existing westbound left-turn lane into acceleration lane for southbound left-turns.
2. Warrants for traffic signal at US 26/Groveland Rd. are not met (would be met in future, however).
3. Use of alternate route by large trucks to avoid sharp turn at US 26/W. Collins Siding Rd. would result in too much out-of-direction travel (south leg of Groveland Rd. would be closed).

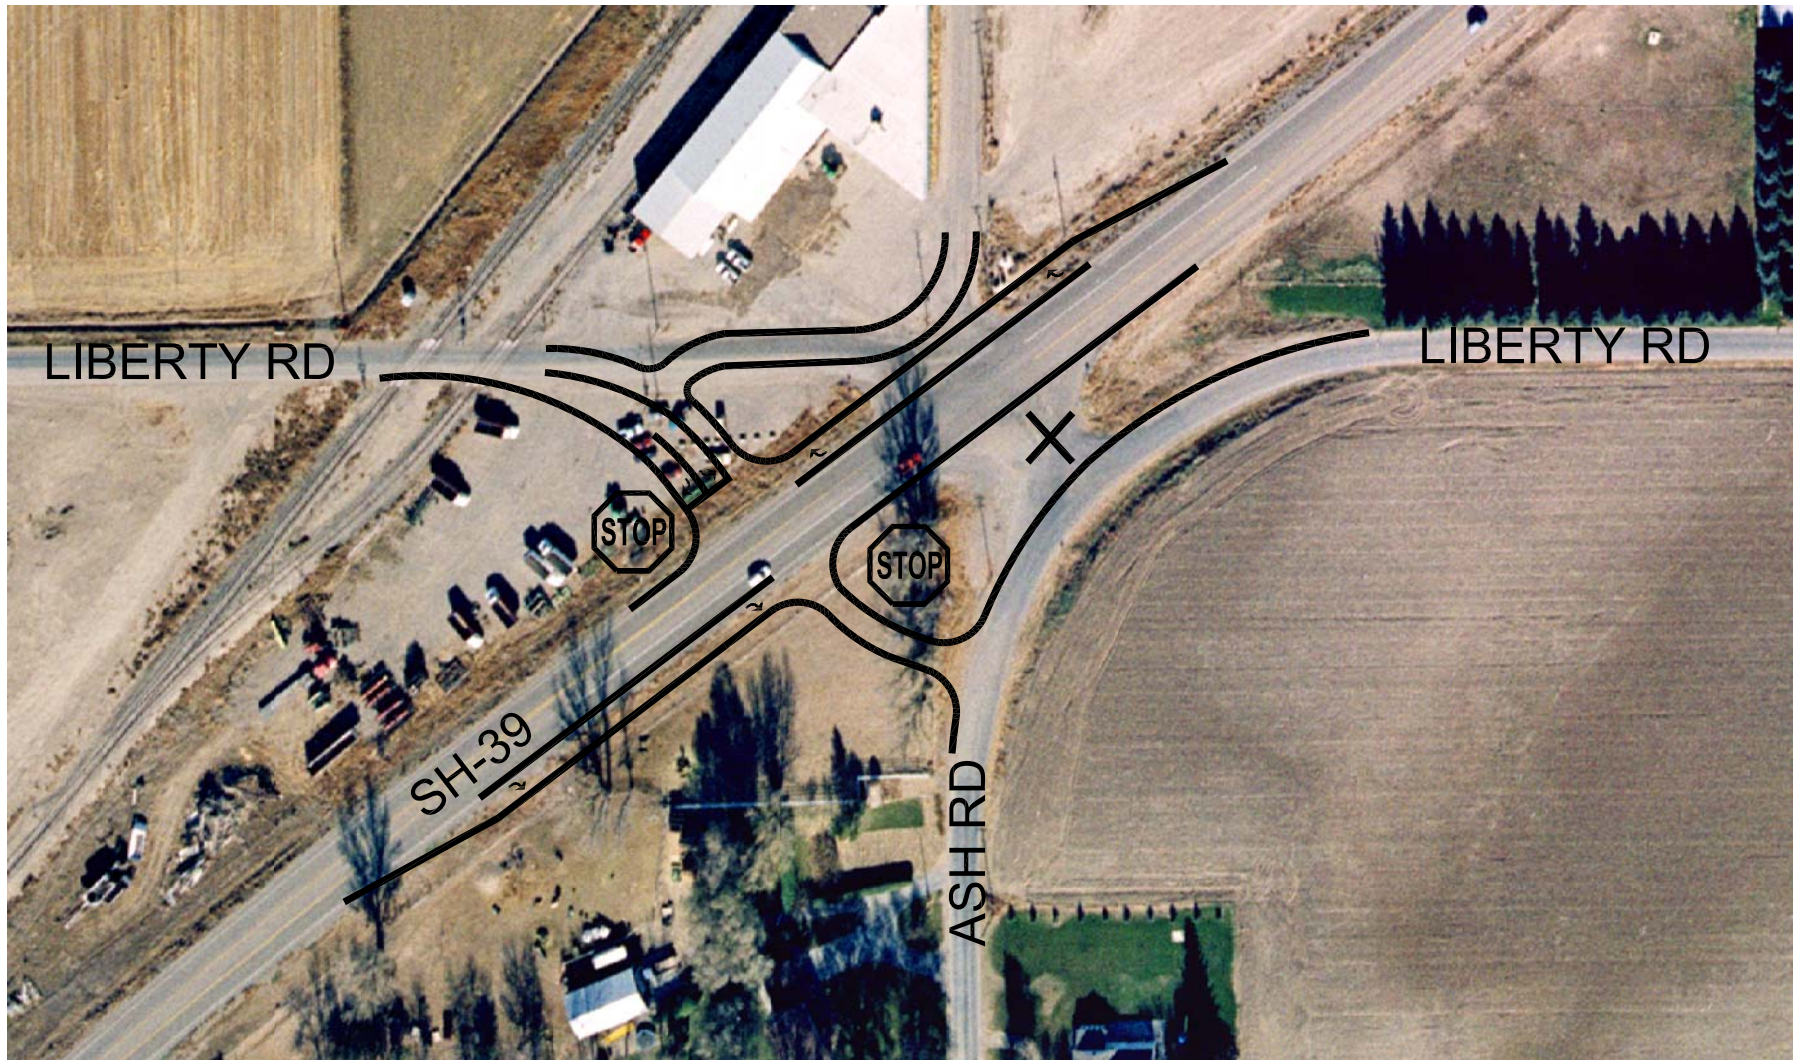
# ***SH-39 at Liberty Road***

1. Realign existing intersection:
  - Close existing Liberty Rd./Ash Rd. intersection.
  - Realign Liberty Rd. at 90-degree angle with SH-39 to south of existing intersection.
  - Construct connector road between new SH-39/Liberty Rd. intersection and Ash Rd.
  - Provide local access connection to property on northwest corner of existing intersection.
2. Construct southbound right-turn lane on SH-39.
3. Maintain adequate striping on minor road approaches to intersection.
4. Construct eastbound left-turn lane on Liberty Rd. (future improvement).
5. Construct northbound right-turn lane on SH-39 (future improvement)

**Figure 4**  
**Realignment of SH-39/Liberty Road**  
**Intersection**

1. Relocation of intersection necessary in order to achieve adequate alignment and reduce number of intersection approaches.

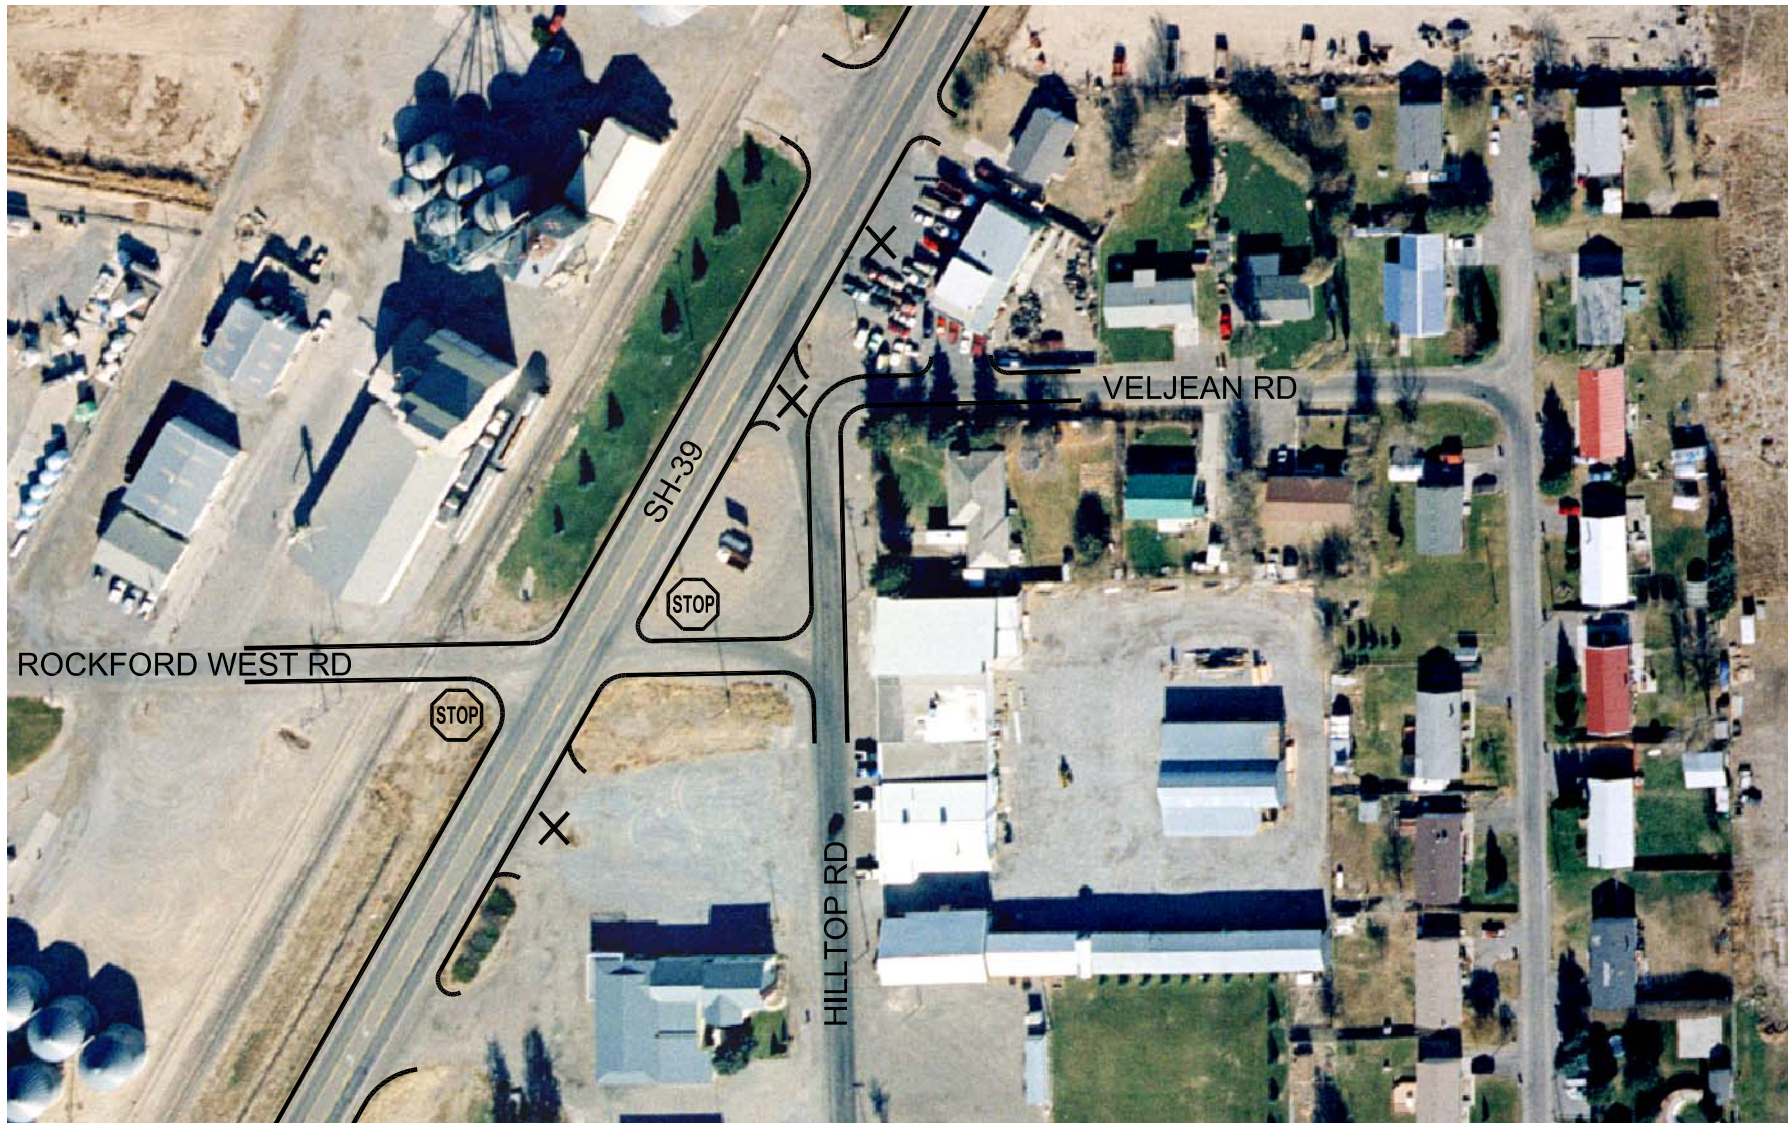
# ***SH-39 at Rockford West Road/Hilltop Road***

1. Eliminate direct access to SH-39 from property on northeast corner of SH-39/Hilltop Rd. intersection; provide new access via Veljean Rd.
2. Close existing SH-39/Hilltop Rd. intersection.
3. Eliminate minor offset between east and west legs of SH-39/Rockford West Rd. intersection by realigning Rockford West Rd.
4. Close north access to SH-39 from property on southeast corner of SH-39/Rockford West Rd. intersection.

**Figure 5**  
**Modification of Access Along**  
**SH-39 in Rockford**

1. Improvements will reduce potential for accidents caused by high density of accesses within this segment.

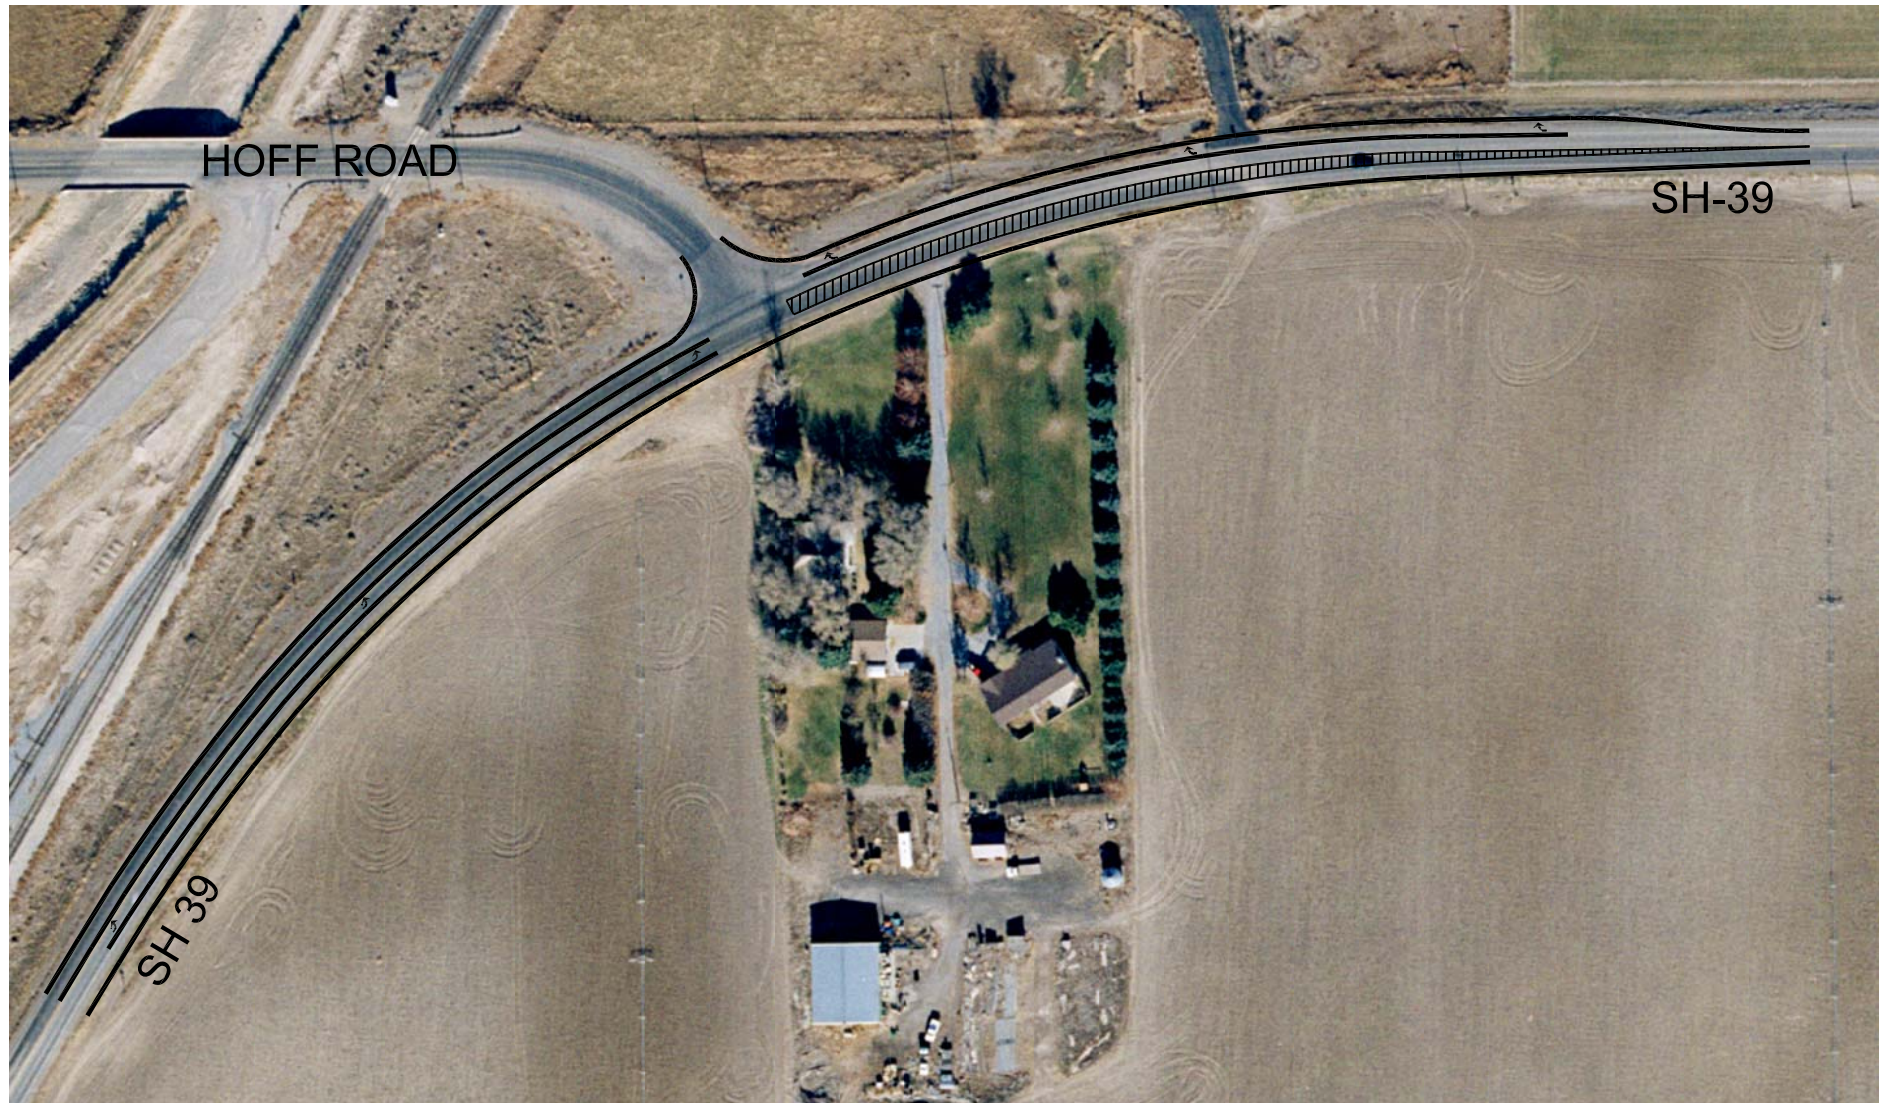
# SH-39 at Hoff Road

1. Construct northbound left-turn lane on SH-39.
2. Construct southbound right-turn lane on SH-39.

**Figure 6**  
**Addition of Turn Lanes at**  
**SH 39/Hoff Road**

1. Southbound acceleration lane not recommended because:
  - No guarantee that construction of acceleration lane along existing alignment of SH-39 would reduce beet spillage problem.
  - To address the beet spillage problem with certainty, superelevation of curve along SH-39 would have to be reduced by realigning curve to a larger radius, resulting in significant impacts to farm and residential property to south of SH-39/Hoff Road intersection.

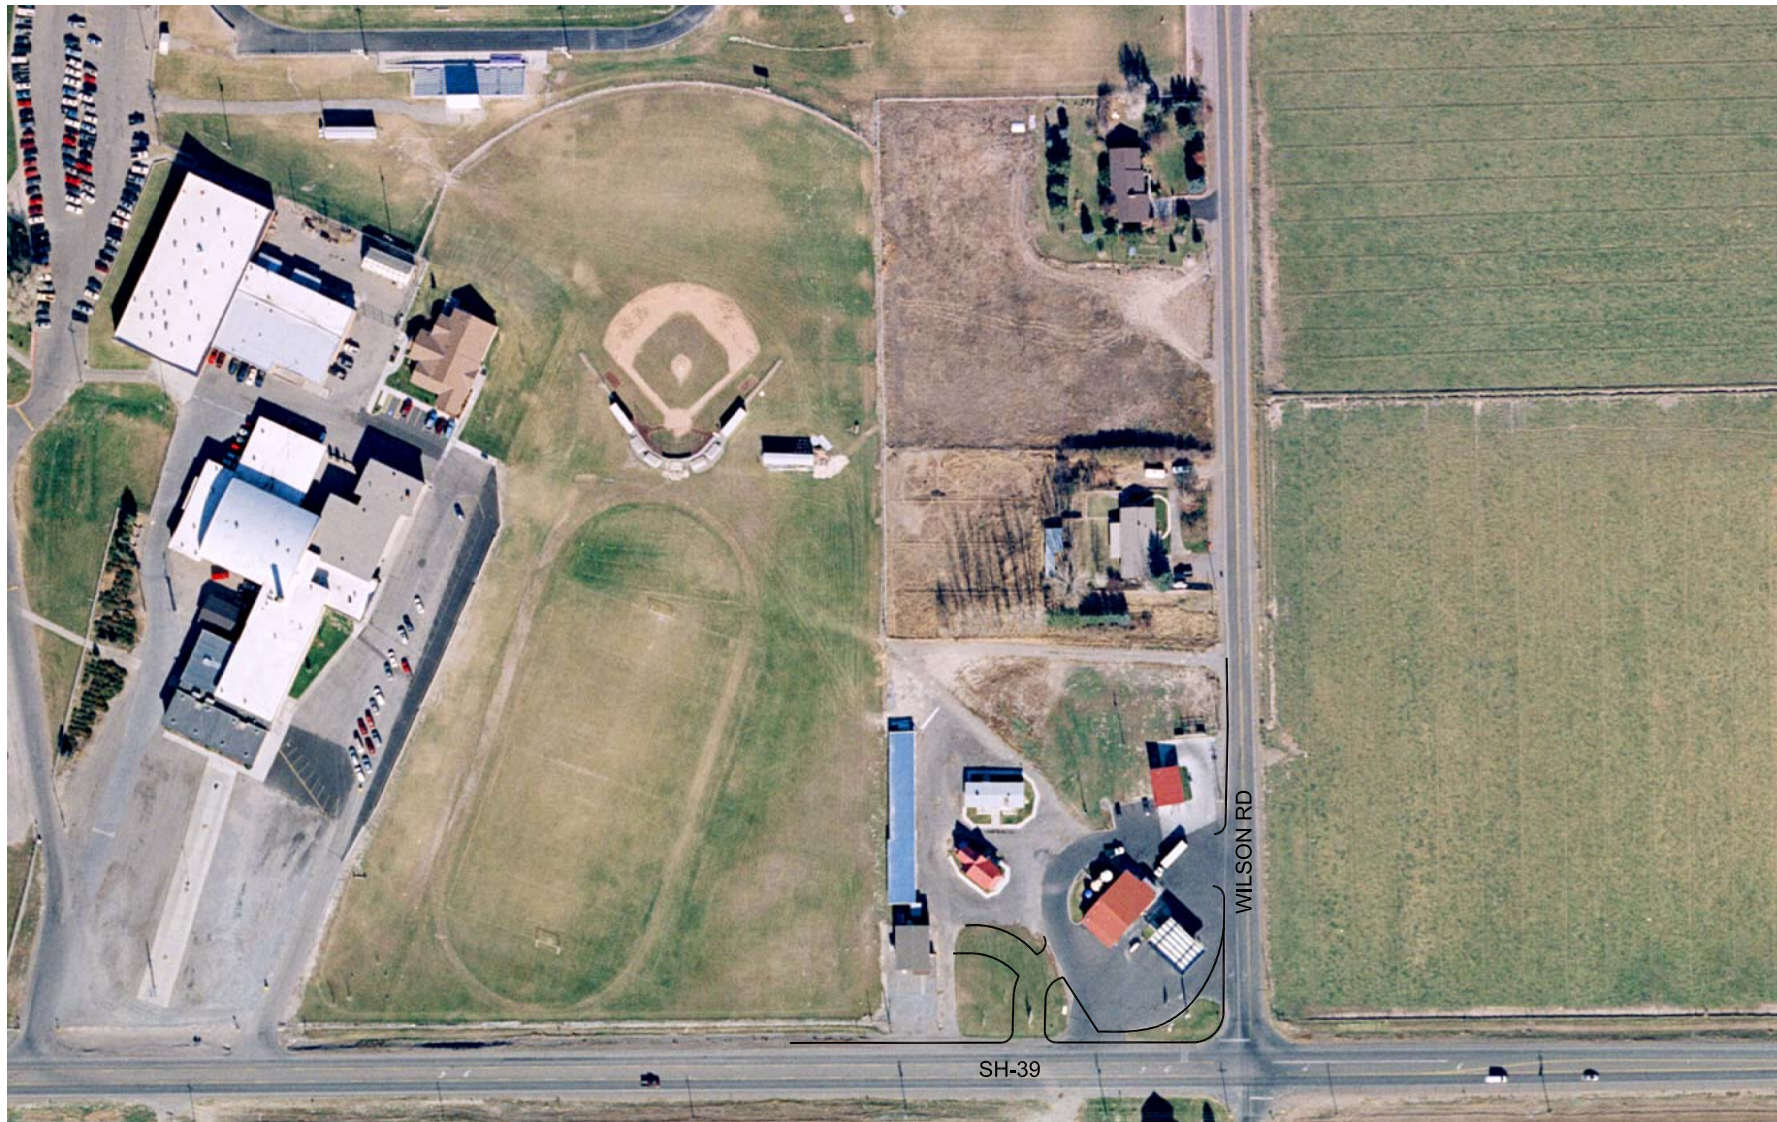
# ***SH-39 at Wilson Road***

1. Install flasher.
2. Modify accesses to commercial properties on northwest corner of SH-39/Wilson Rd. intersection:
  - Move convenience store access on north side of SH-39 to roughly 200 feet west of intersection; combine with access to adjacent property.
  - Convert existing unrestricted convenience store access on west side of Wilson Rd. to single driveway located roughly 200 feet north of intersection.

**Figure 7**  
**Modification of Access at**  
**SH 39/Wilson Road**

1. Flasher would increase driver awareness of approaching intersection and need to stop.
2. Modification of accesses to commercial properties near intersection would be effective overall safety measure.
3. Speed humps and rumble strips on Wilson Rd. approaches would not adequately address failure-to-yield problem and may create additional problems.

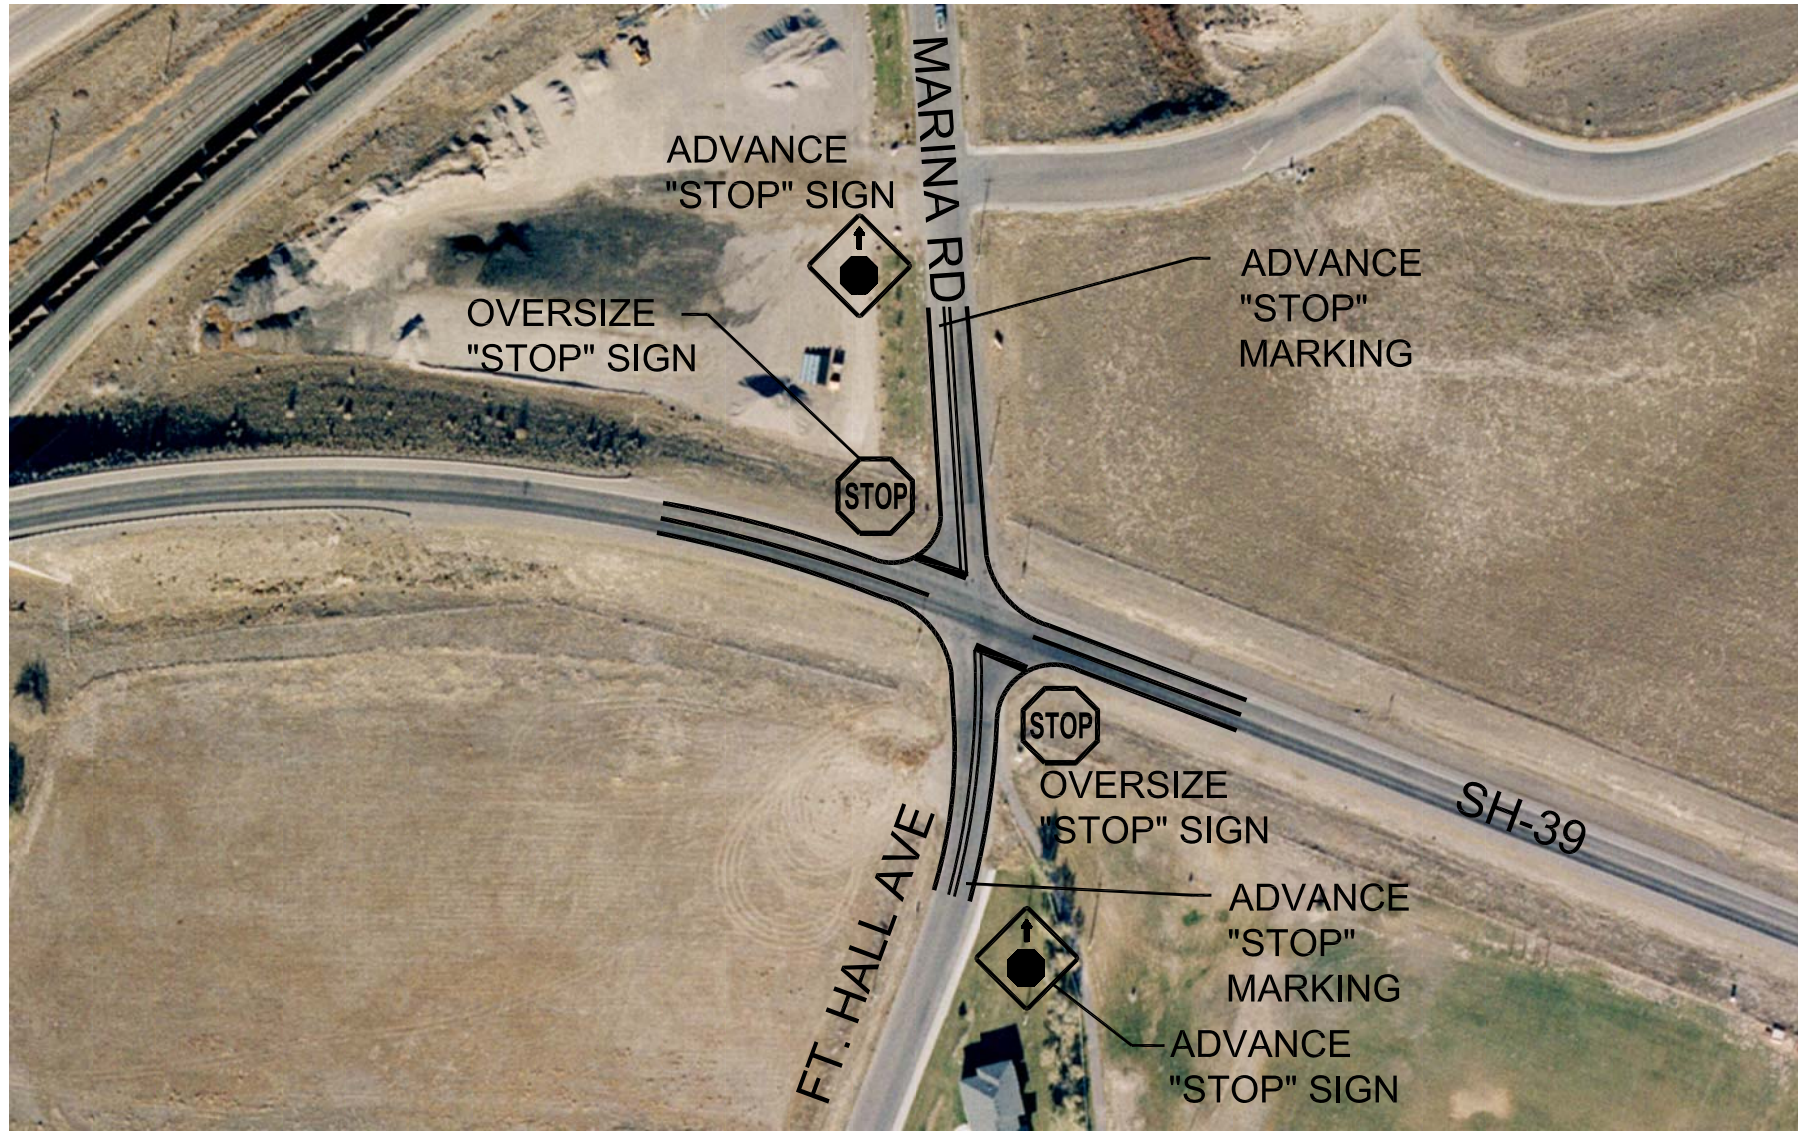
# SH-39 at Ft. Hall Ave./Marina Road

**Figure 8**  
**Signing and Striping Improvements at**  
**SH 39/Ft. Hall Ave/Marina Road**

1. Adequate pavement markings and delineation on Ft. Hall Ave. – Marina Rd. are necessary, basic improvements that should be installed and monitored for effectiveness prior to considering other improvements.
2. Speed hump and rumble strip on eastbound approach of Pioneer Rd. would not adequately address problem of drivers ignoring stop sign and may create additional problems.
3. Turn lanes not recommended due to proximity of U.P.R.R. bridge approach to intersection (would require major fill or construction of retaining walls for bridge approach and relocation of bridge guardrails).

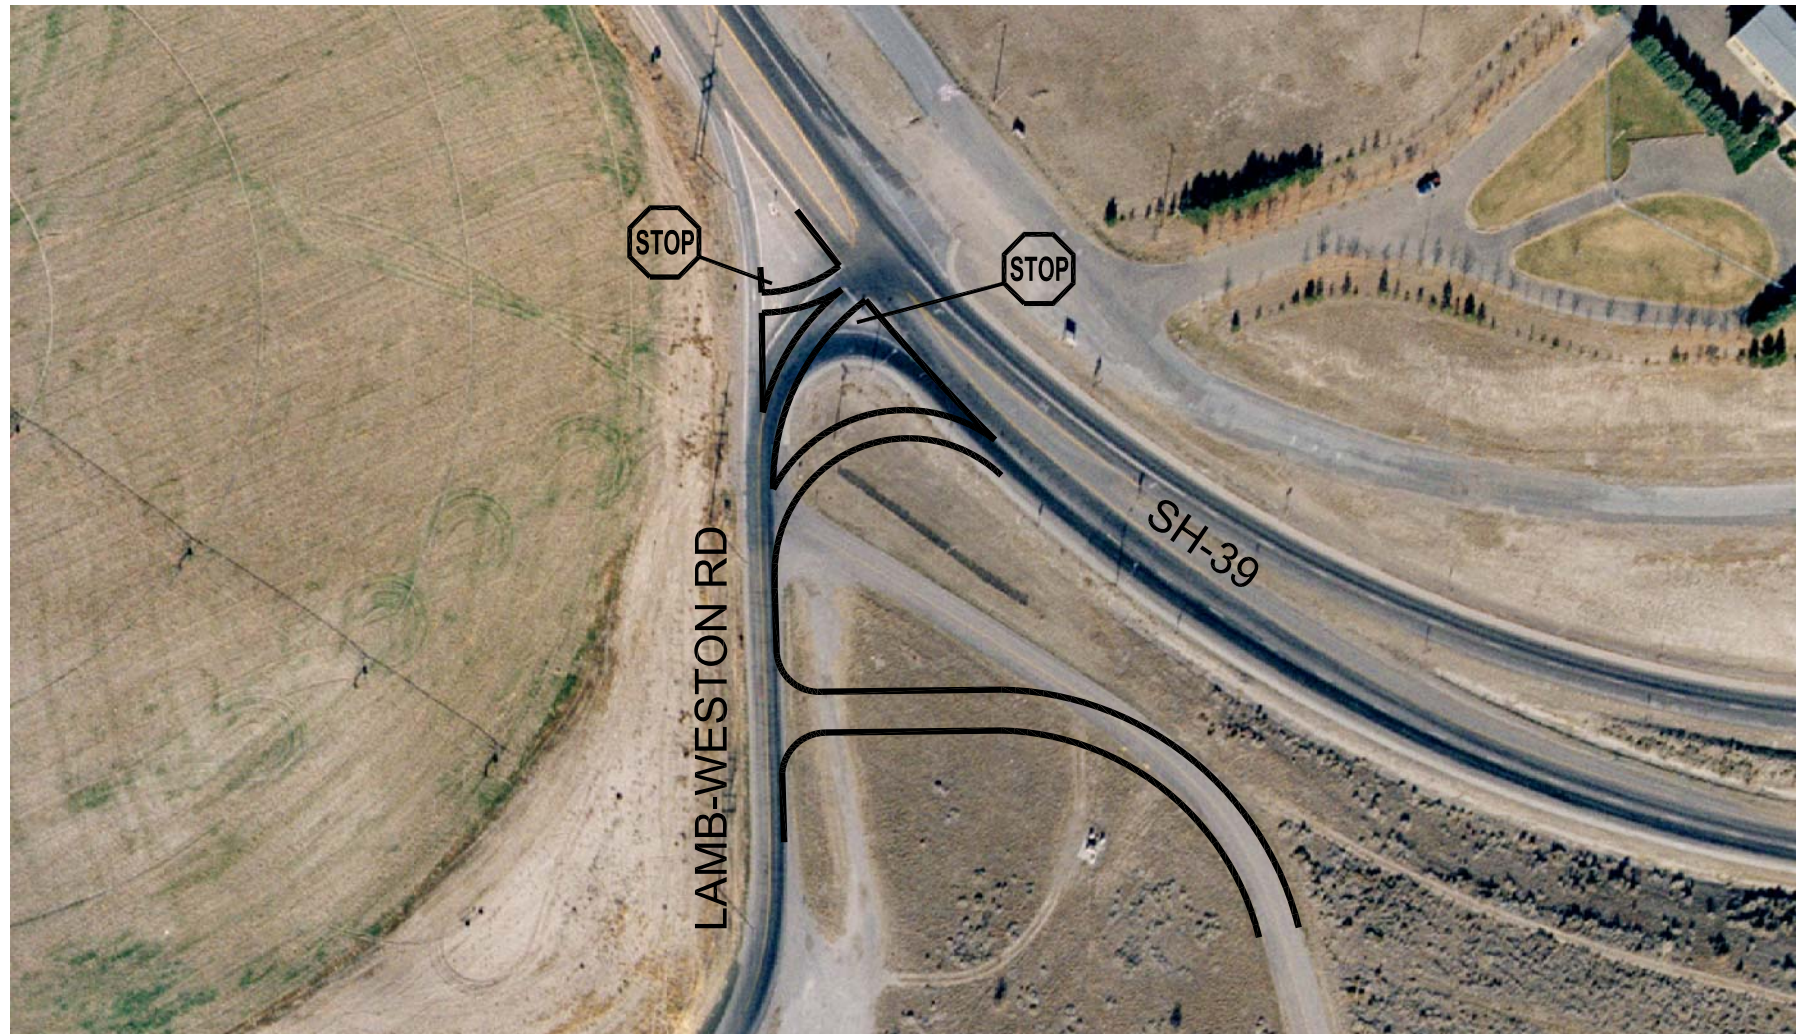
# ***SH-39 at Lamb-Weston Road***

**Figure 9**  
***Curve Widening for Northbound  
Right-Turn at SH-39/Lamb-Weston  
Road Intersection***

1. Rebuilding existing curve would have lower cost and property impacts than realignment of Lamb-Weston Rd.
2. Change in intersection control would likely be more effective than installation of yield line and would cost less than reconstruction of intersection.
